## DHAKUAKHANA WATER RESOURCES DIVISION, DHAKUAKHANA

**Major Achievement of Dhakuakhana W.R.  
Division, Dhakuakhana in recent years**

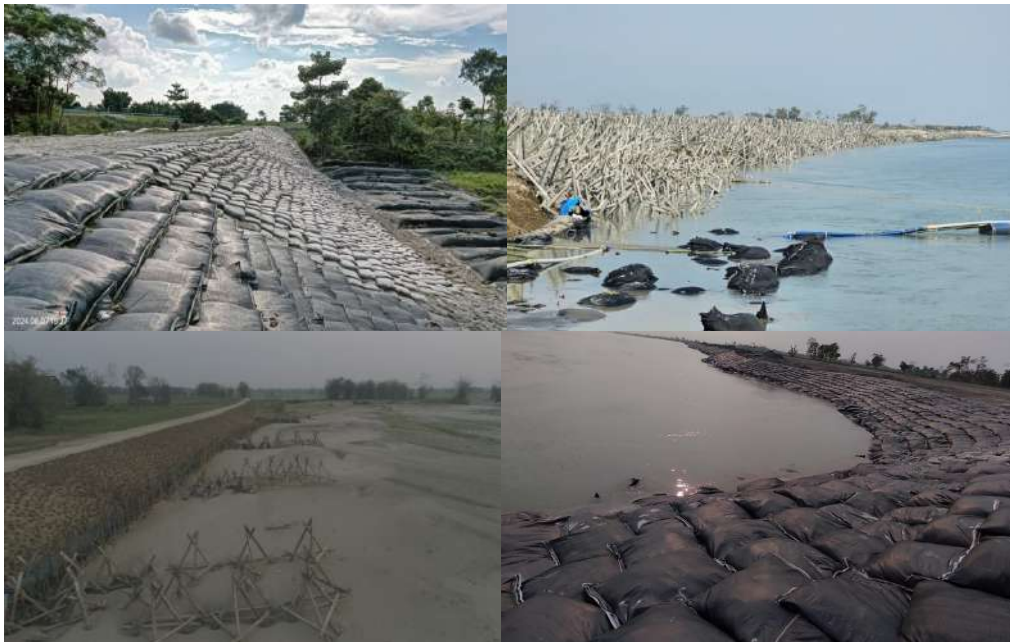
<b>Name of Scheme</b>	:	Extension of Sampora L/B embankment from Gurathali Chapori to Dhakuakhana PWD road to Protect the Ghilamara township and its adjoining areas from the flood inundation of Kumatia/Sampora river.
<b>Estimated Amount</b>	:	Rs. 947.00 Lakh
<b>Date of Starting</b>	:	15.02.2022
<b>Date of Completion</b>	:	30.01.2023

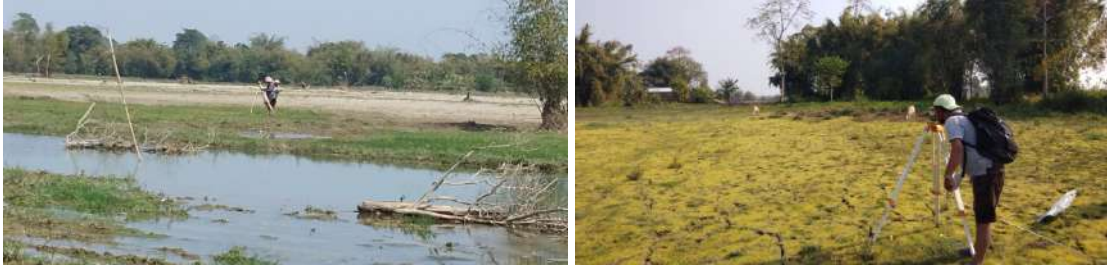
- The flood havoc is created by the Sampora river (Jiadhal/Kumatiya) in Dhakuakhana Co-District under Lakhimpur District.
- The Road communication have been disrupted by the flood of Sampora river delinking a major part of Dhakuakhana Co-District area of the District.

- A large nos. of house, schools and other Govt. & private buildings and assets including hectares of homestead and cultivated land was Devastated and silted by the river.

**(PHOTOGRAPHS BEFORE EXECUTION OF THE SCHEME)**

- To address the long-standing issue of the Sampora river, the government approved a plan in 2021 to construct a 4.52 Km new embankment from Gurathali Chapori to Dhakuakhana PWD Road in L/B of river Sampora.
- The initiative was executed, resulting in the reclamation and protection of roughly 12500 hectares of land. This land features heavily populated 12 villages and is abundant in agricultural activities, now shielded from the impact of floods.

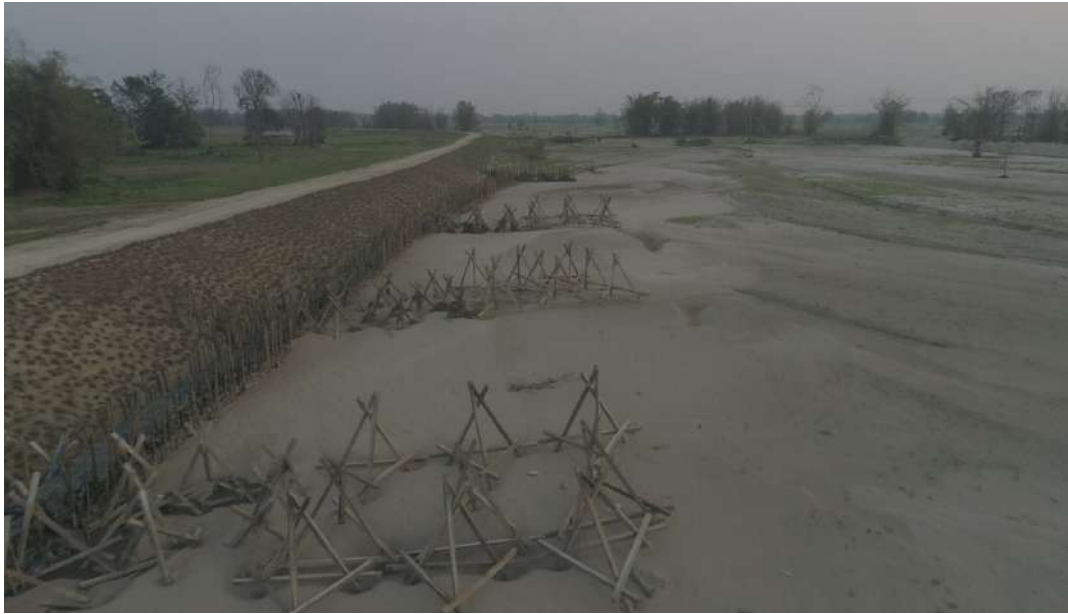
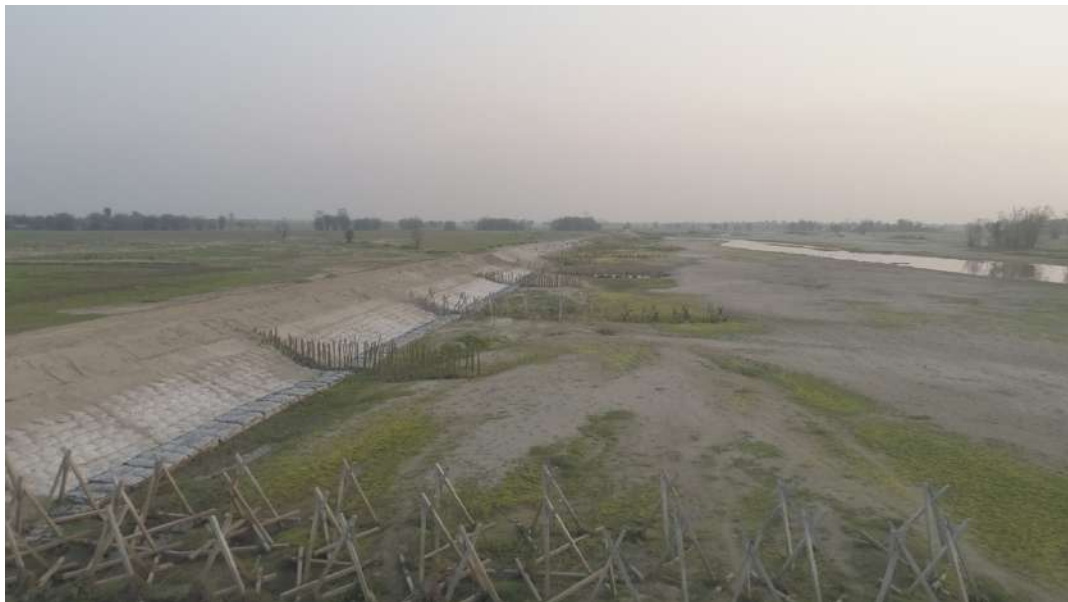
**(PHOTOGRAPHS AFTER EXECUTION OF THE SCHEME)**

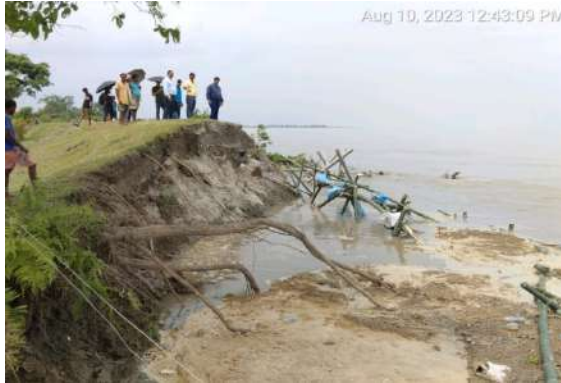
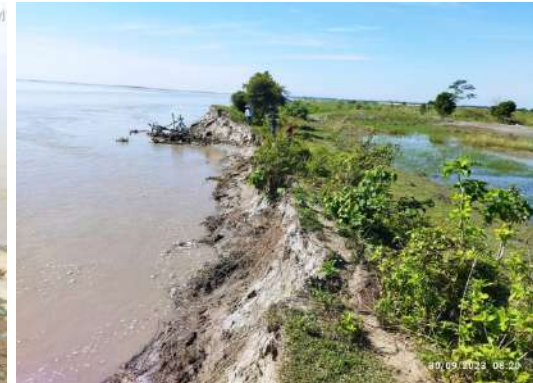
- During the year 2023, erosion at Matmara is taking place as rainy season has come due to rise & fall of water level. In the 1<sup>st</sup> week of July, 2023, it is observed that an incoming channel at upstream of Matmara area of river Brahmaputra has become more active and a quantum of discharge rushing through the channel exerts with high pressure and hitting the bank of Matmara area perpendicularly causing heavy damages by erosion including shifting of bank line to the Northern bank of the river depositing the silt on the opposite (southern) side.

- The nose portion of the old dyke has already been eroded away and huge portion of land mass also been engulf. The affected reach length was found to be about 650m at present. The river course is coming very closer to the old abandoned embankment and flowing along it and causing heavy ravage by erosion to the area and also posing to threat to the Geo-dyke at Matmara.

**(PHOTOGRAPHS BEFORE EXECUTION OF THE SCHEME)**

- Seeing the gravity of the situation, the Govt. has approved the scheme during the year 2023-24 under RIDF and was successfully executed with the provision of construction of 3 (three) Nos. of Check bund and anti erosion measures with Geo Bags. The scheme was started on 17.03.2024 and completed on 18.11.2024. Now, the erosion issue has been partly resolved, and approximately 10 hectares of land has been reclaimed.

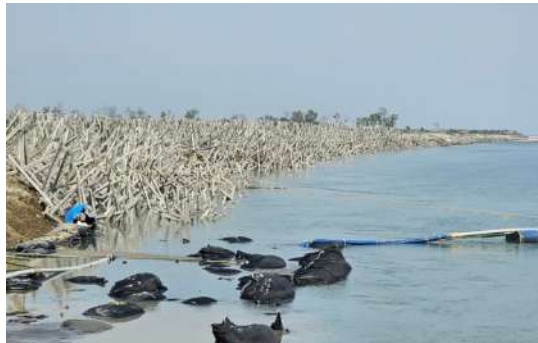
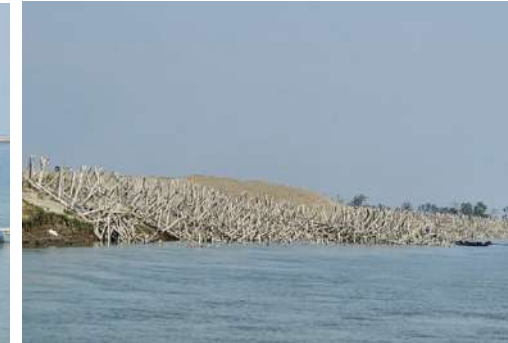
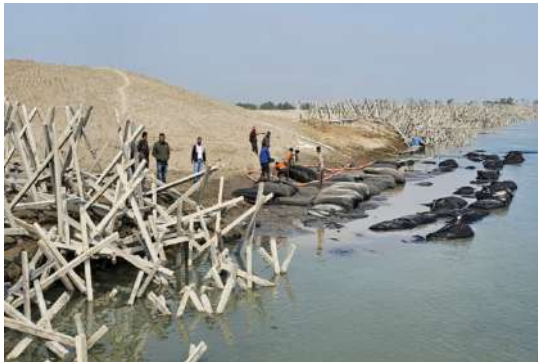
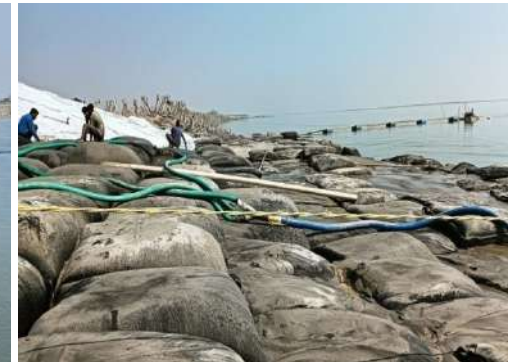
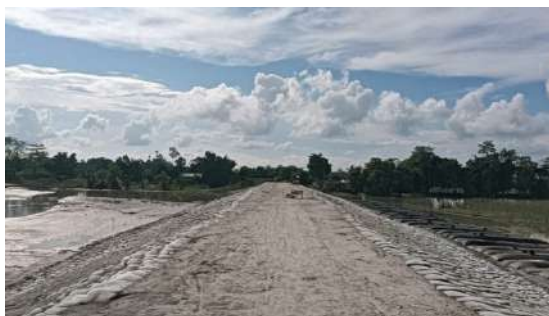
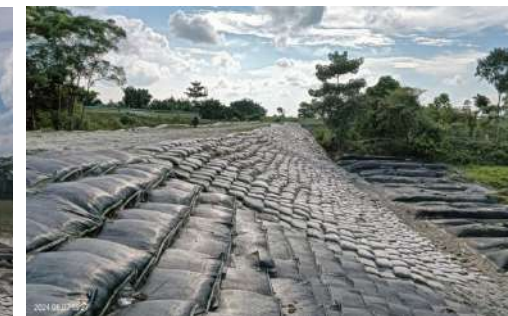
**(PHOTOGRAPHS AFTER EXECUTION OF THE SCHEME)**

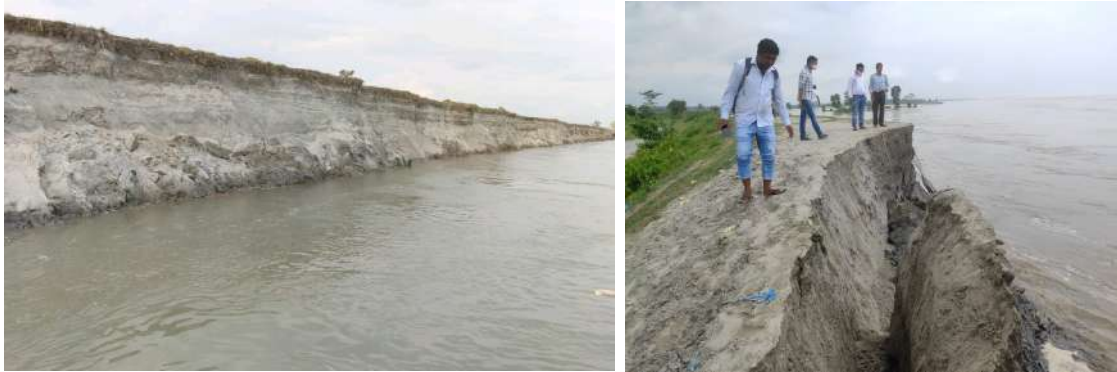
- During September, 2020, it was observed that an incoming channel at upstream of Baghchuk area has become very active and a quantum of discharge rushing through the channel and hitting the Bandana-Baghchuk area almost perpendicularly causing heavy damage by erosion and flood devastation including shifting of bank line to the northern bank of river Brahmaputra for a reach length of about 3000m at a stretch at Bandana Baghchuk area. As a result huge portion of land mass has been eroded away. But the erosion had eventually stopped due to falling of Water Level of the river as the flood season is finally over at that time in last year.

- Off late, it is observed that the incoming channel has become one of the major channels of Brahmaputra with a very heavy mass of flow of water running in high velocity and comes very closer to this area, leaving minimum bank margin about 450m at Baghchuk area from Sisi-Tekeliphuta main Embankment, causing endanger to the Baghchuk area in near future.

**(PHOTOGRAPHS BEFORE EXECUTION OF THE SCHEME)**

Seeing the gravity of the situation, the Govt. has approved the scheme during the year 2021-22 under SOPD-G and was successfully executed with the provision of anti erosion measures with Geo Bags and PSC Porcupine screens. The scheme was started on 11.01.2022 and completed on 30.06.2023. Now, the erosion issue has been partly resolved, and approximately 7 hectares of land has been reclaimed.

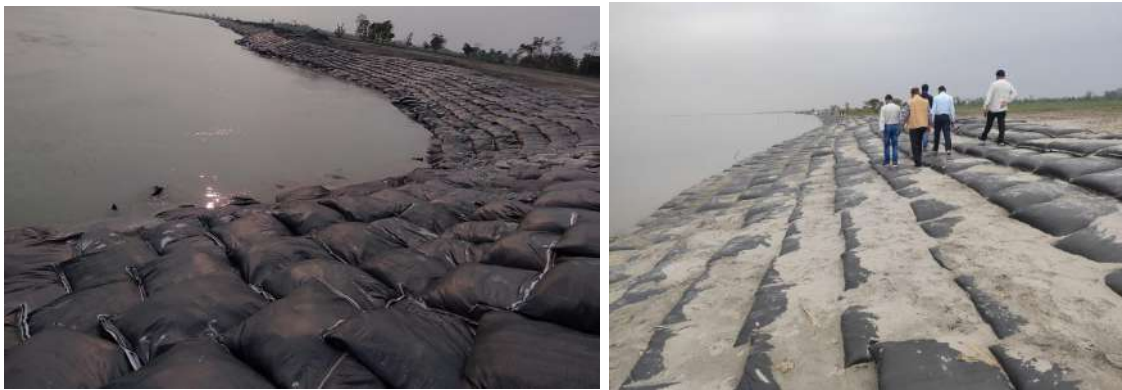
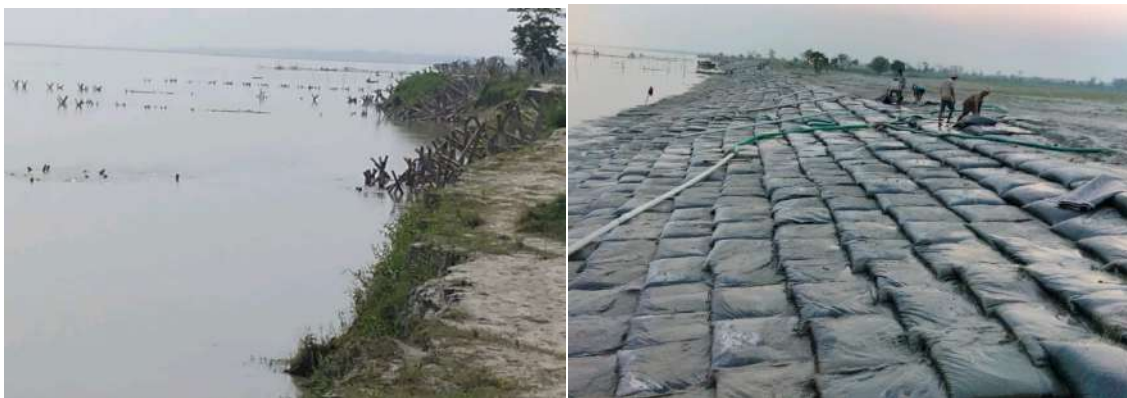
**(PHOTOGRAPHS AFTER EXECUTION OF THE SCHEME)**
